**South 4 Group Fire at PNO
TPC Group LLC
June 15, 2020**

Executive Summary

Introduction

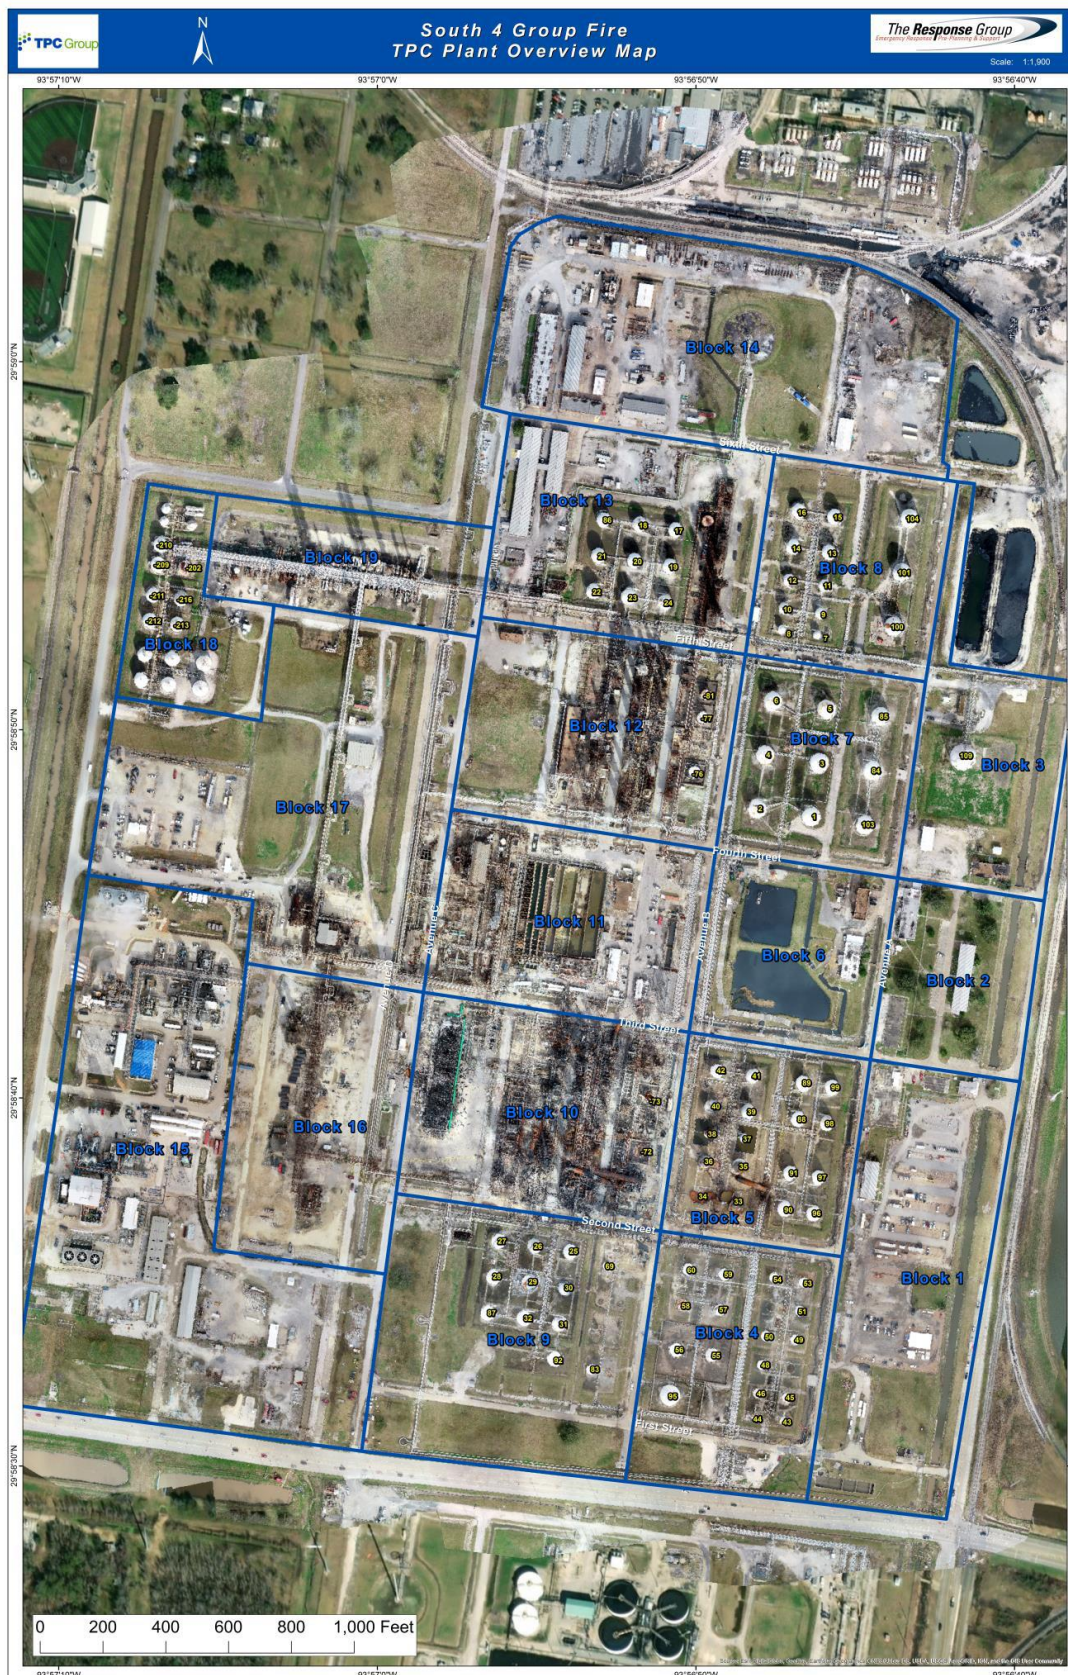
The above photo provides a view of the Site post-event.

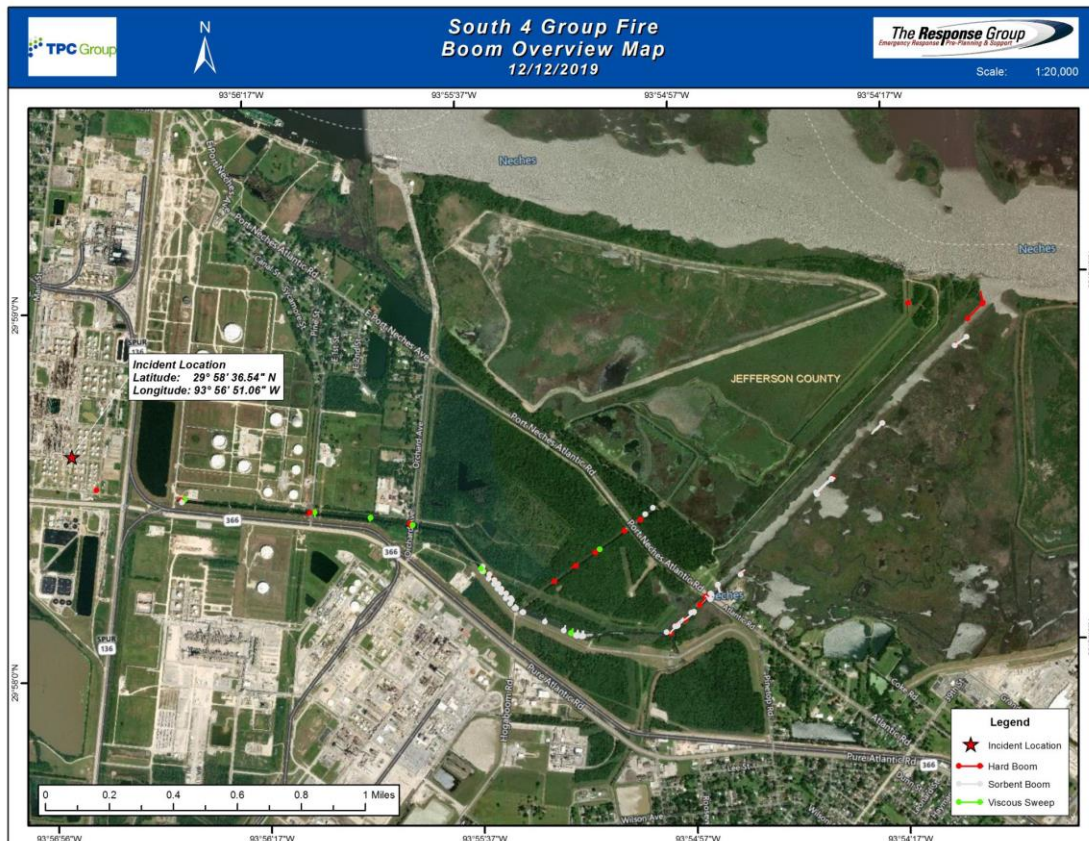
The *Division Overview Map* below depicts the boundaries for Divisions A – E. Any discharge from the response site flowed into the discharge canal in Divisions A, B and C, then to the Star Lake Canal (Division D) to the Neches River. Division E was included in the response protection measures because waters from the discharge canal can be pumped into this area as a tertiary treatment and then flow into the Neches River. The *Boom Overview*

Map below depicts the locations that the OSRO contractor placed a variety of booms and other mitigation measures.

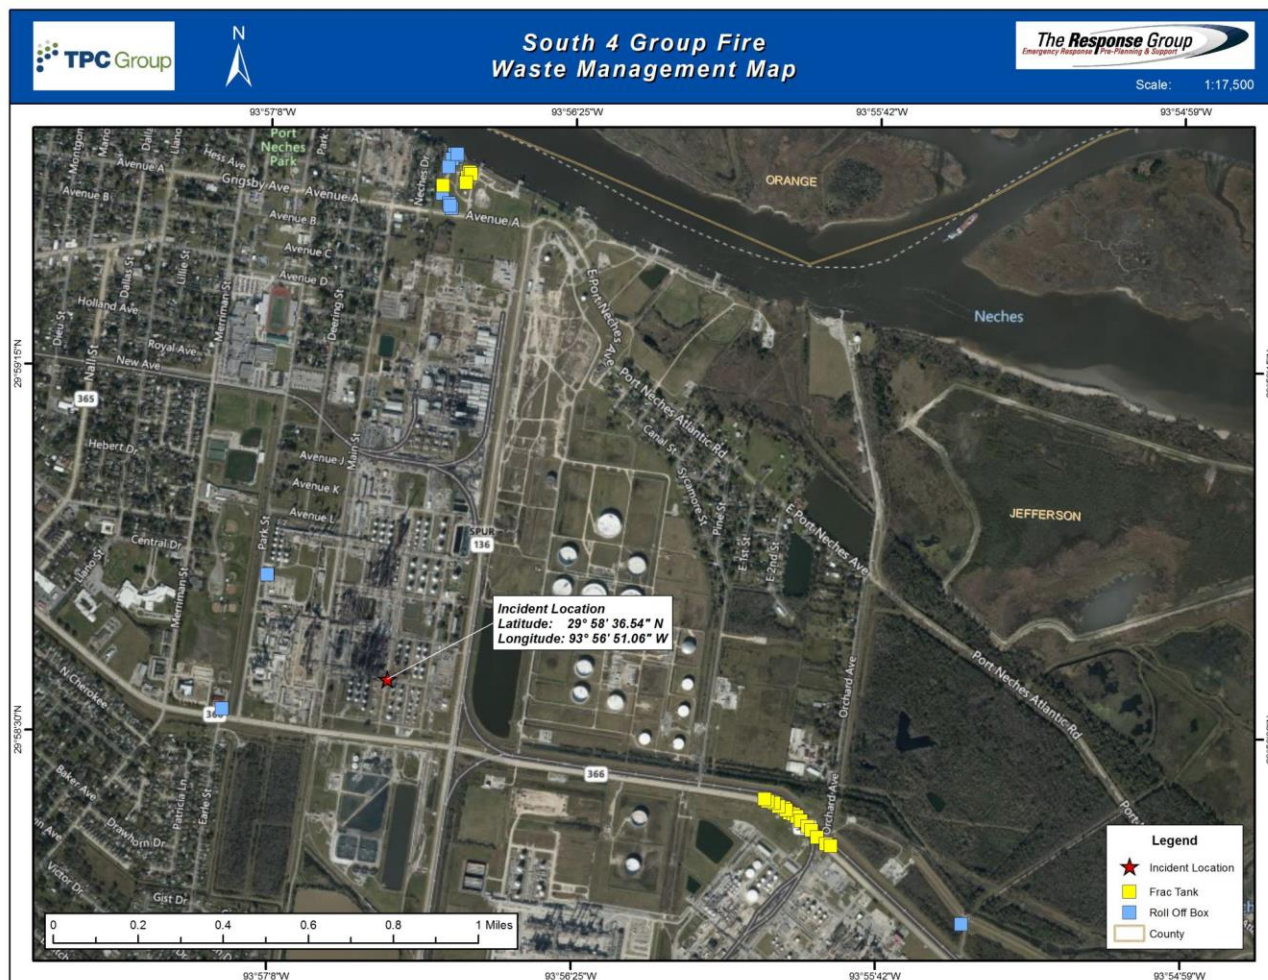
All wastes generated by the incident response were staged and managed on-site or in close proximity to the site. All liquid wastes were managed in 20,000-gallon frac tanks. The majority of the frac tanks were located along Highway 366 in close proximity to the water operations that were generating the waste. A lane of Highway 366 was blocked off to provide a safety buffer for the stored materials and the contractors handling the wastes. All solid/bulk wastes that were generated from the incident response were managed in various types of roll-off containers and the majority were staged at the TPC dock property located North of the facility along the Neches River. Please see the *Waste Management Map* to view the staging locations of all response related waste.

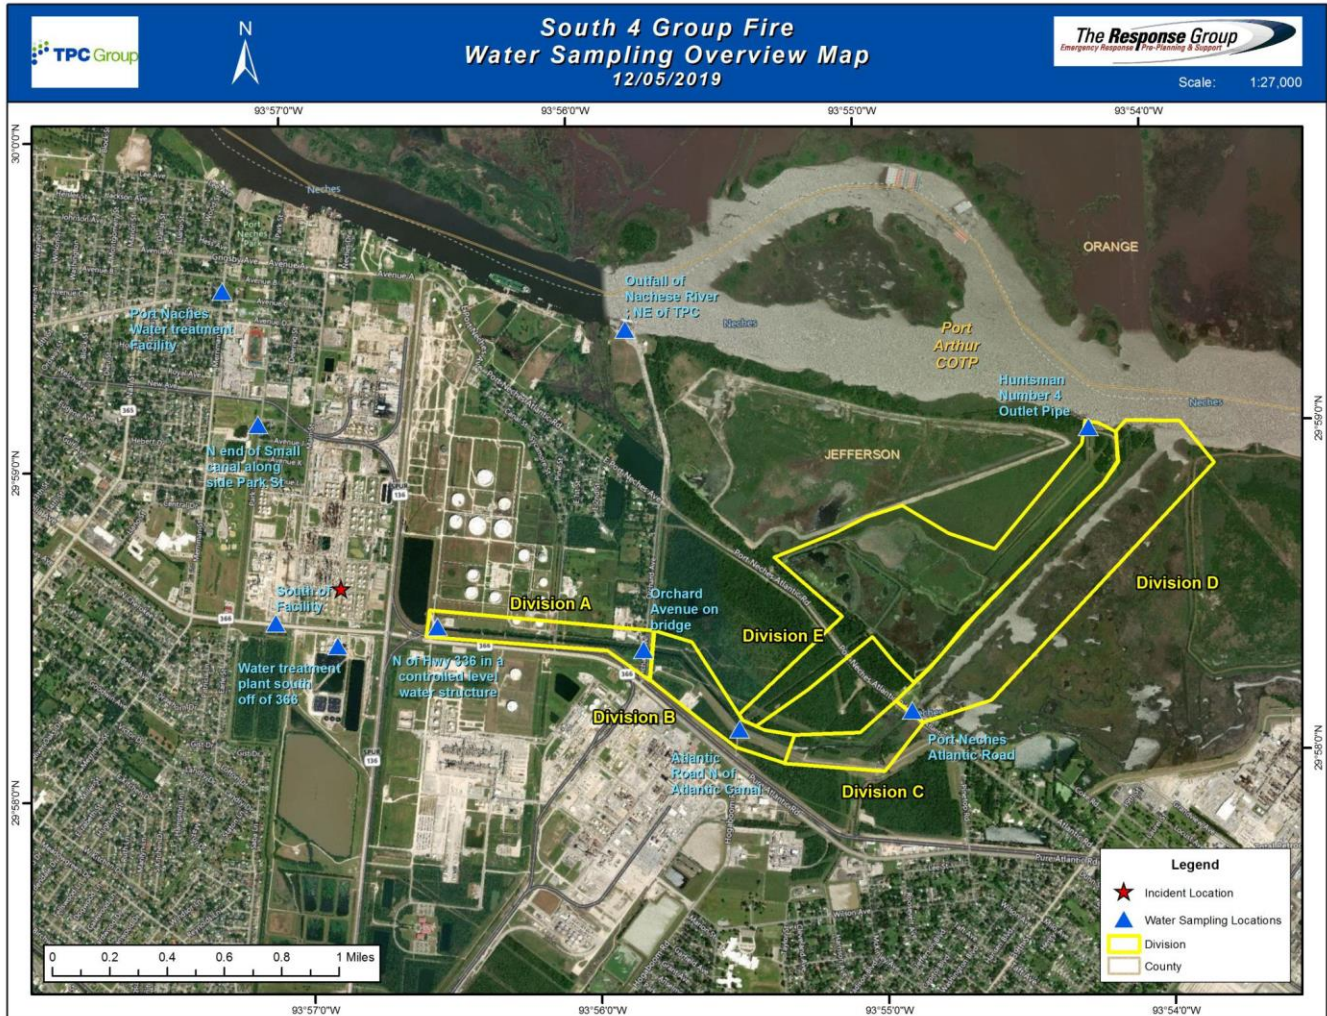
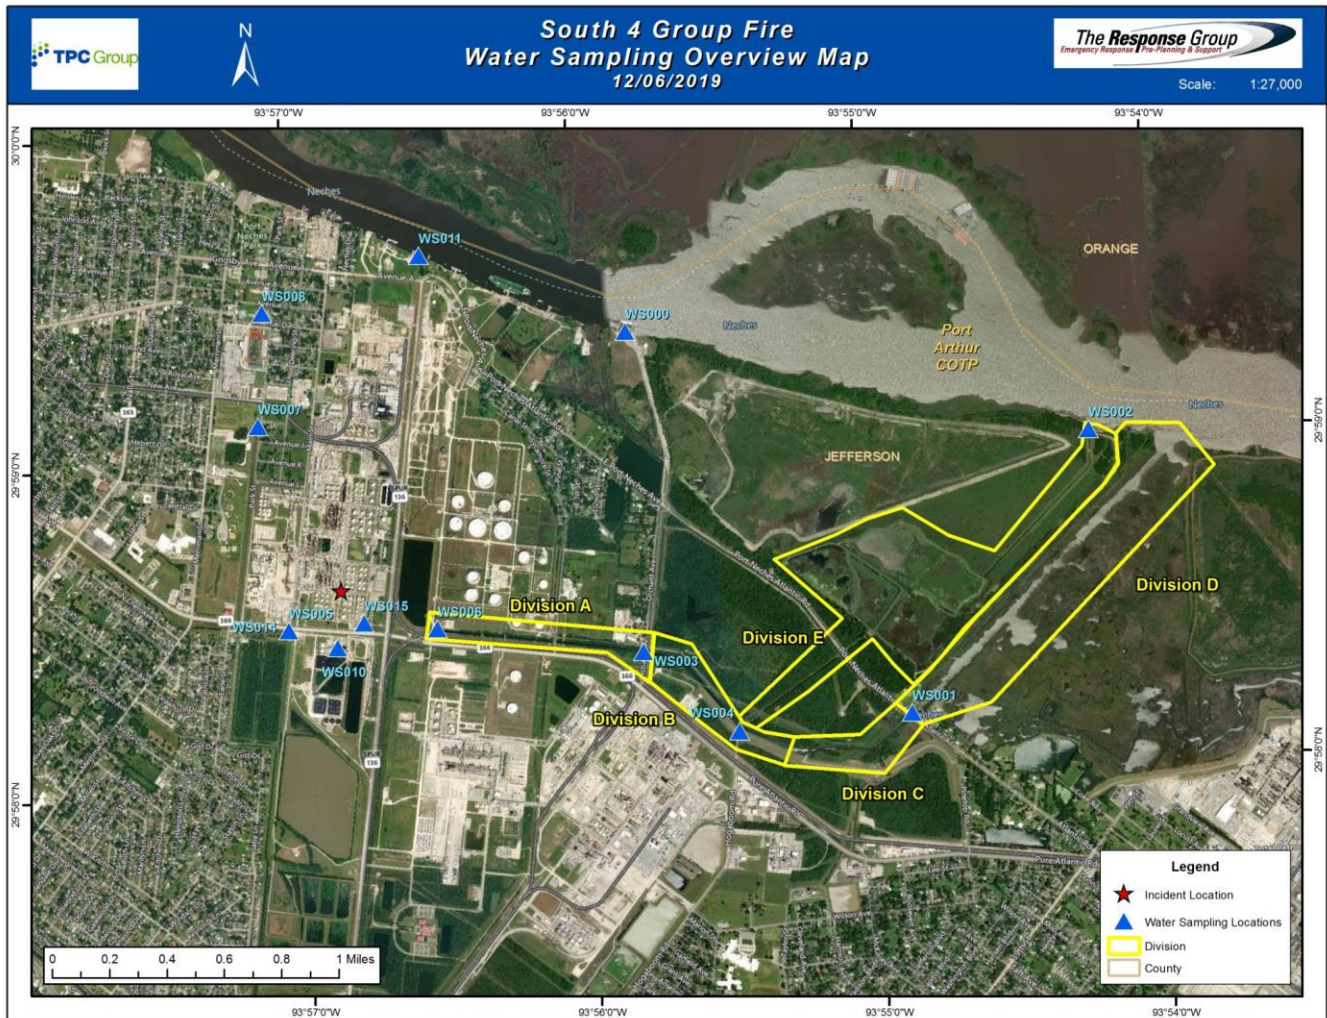
Table 2.1.1 Surface Water Sampling Locations and Descriptions¹

TPC engaged the Center for Toxicology and Environmental Health (CTEH) to perform surface water sampling shortly after the incident occurred. Fire water runoff was produced in response to firefighting activities on-site. Every effort was made to contain as much of the firefighting water runoff as possible within the drainage systems and ponds within the facility. Additional runoff storage capacity was also utilized at the Joint Waste Water Treatment Plant (JWWTP) owned and operated by Huntsman (Indorama), TPC and Lyon Elastomers. Some of the firefighting water runoff flowed from the TPC site to the JWWTP and then to the Neches River. Alternately, the runoff that could no longer be contained within the system overflowed Outfall 201 from the TPC site to the discharge canal to the Star Lake Canal to the Neches River or was pumped to Huntsman's tertiary treatment and then to the Neches River (Divisions A – E as discussed in the Water Ops section of this report). Surface water sampling activities by CTEH began on the evening of the event. Surface water sampling was primarily focused on areas in proximity of outfall locations to evaluate downstream movements of runoff from the TPC facility and to assess the potential for offsite chemical impacts. The *Environmental Sampling and Analysis Plan* was approved by UC. A total of 265 samples were analyzed and *Table 2.1.1 Surface Water Sampling Locations and Descriptions* for a summary of the sampling location descriptions, number of samples collected and the date range of sampling. Nine drinking water samples were taken with no exceedances of TCEQ or USEPA concentration/contaminant levels. Surface water sampling for PFOS/PFOA resulted in no exceedances of drinking water advisory levels. Results from surface water samples were compared to various health-based screening values, depending on the reported water use and community access. There were no exceedances of protective concentration levels or maximum contaminant levels set by TCEQ or USEPA.

Location Code	Location Description	Samples Collected	Sample Start Date	Sample End Date
WS000	Baseline; Huntsman Dock at Neches River; NE of TPC	1	11/27/2019	11/27/2019
WS001	Port Neches Atlantic Road; downstream from Outfall 001 (permitted discharge location)	22	11/28/2019	12/9/2019
WS002	Water Treatment Wetlands Outlet; Outfall 004 (permitted discharge location)	37	11/27/2019	1/31/2020
WS003	Orchard Avenue on Bridge over 001 Canal	39	11/28/2019	1/31/2020
WS004	Outfall 001 canal by Huntsman ditch cut, N. of Hogaboom Rd at Pure Atlantic Rd / Hwy 366; Outfall 001 (permitted discharge location)	22	11/29/2019	12/9/2019
WS005	South of Facility; pond parallel to Hwy 366	1	11/29/2019	11/29/2019
